# Infrared Inspection

## Infrared Thermography Inspection **Building Recertification** Electrical system operating at 400A or higher

Inspection Details	
Thermographer	Humberto Suarez
Company Name	Evolve Property Inspections
Client	SAMPLE
Inspection Date	August 29th, 2024
Address	00 NW 000th St Miami, Florida
Report Name	Electrical Thermography

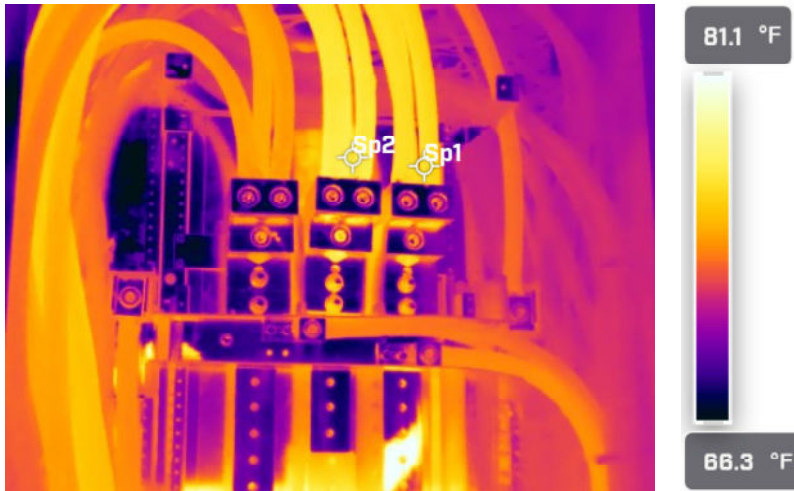
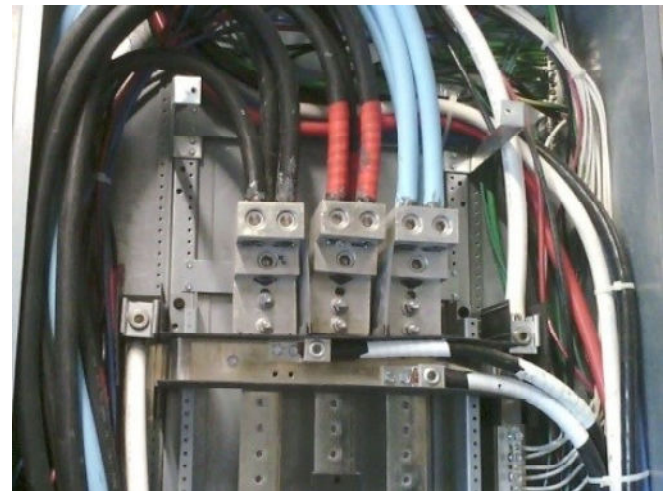
Floor	1
Location	Electrical Room
Equipment	MDP Top
Item	1
Details	Y
Anomaly	Normal
Recommendation	No action

Severity: **Normal**

**No thermal anomalies or deficiencies found during initial inspection.**

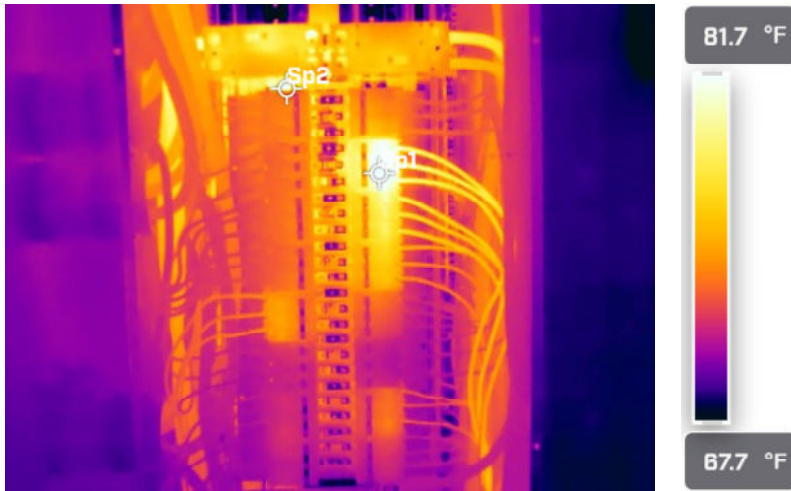
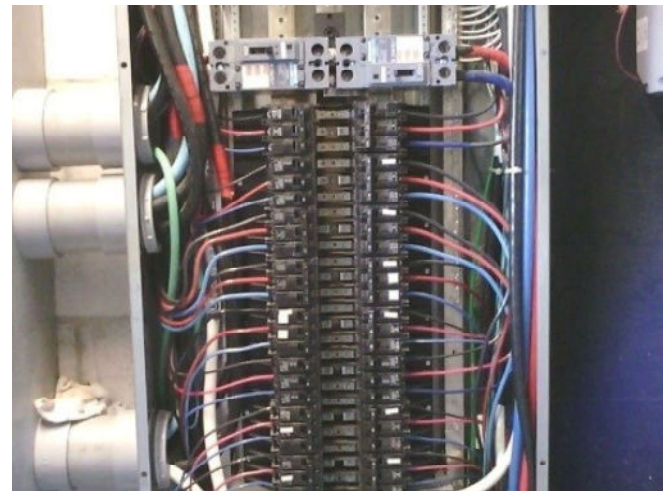
Floor	1
Location	Electrical Room
Equipment	MDP Middle
Item	1
Details	Y
Anomaly	Normal
Recommendation	No action

Severity: **Normal**

**No thermal anomalies or deficiencies found during initial inspection.**

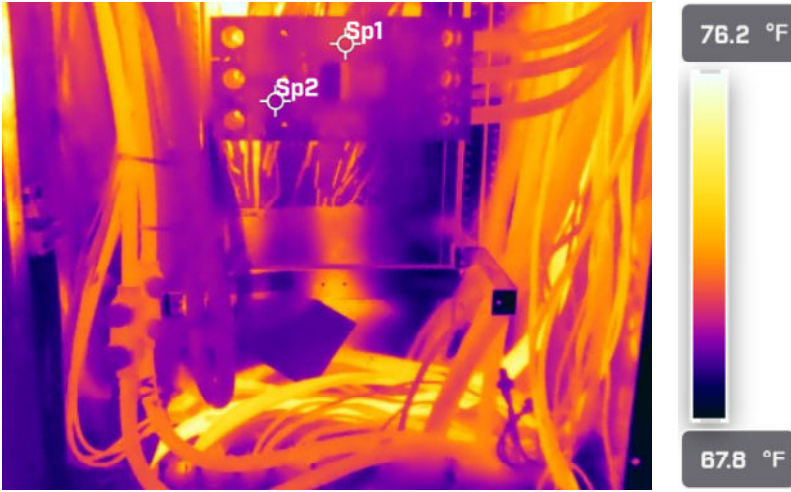
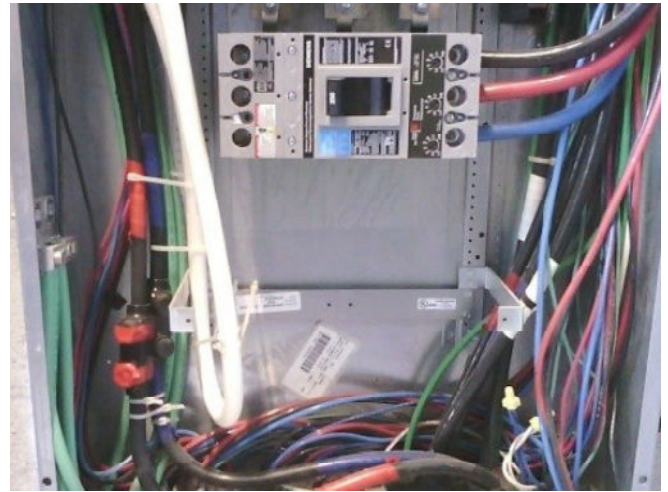
Floor	1
Location	Electrical Room
Equipment	MDP Bottom
Item	1
Details	Y
Anomaly	Normal
Recommendation	No action

Severity: **Normal**

**No thermal anomalies or deficiencies found during initial inspection.**

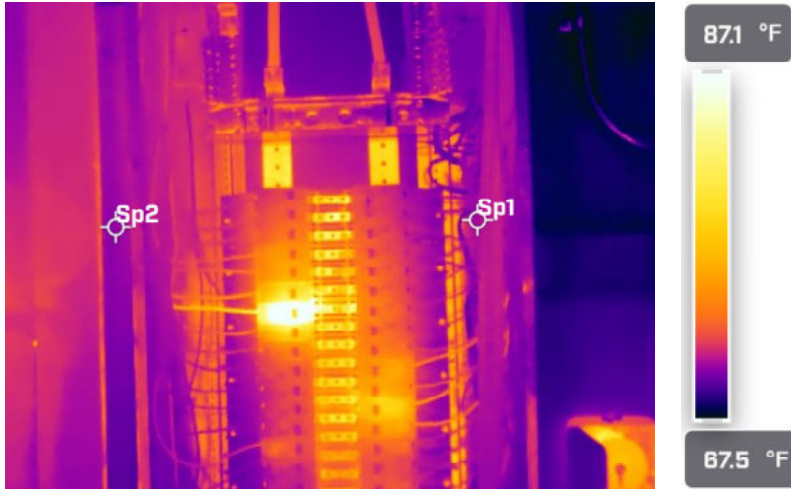
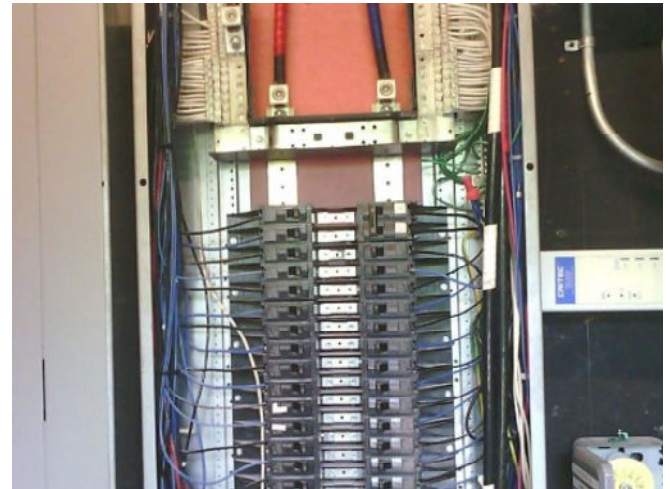
Severity: **Normal**

Floor	1
Location	Electrical Room
Equipment	Breaker Panel Top
Item	Panel LA
Details	Y
Anomaly	Normal
Recommendation	No action

**No thermal anomalies or deficiencies found during initial inspection.**

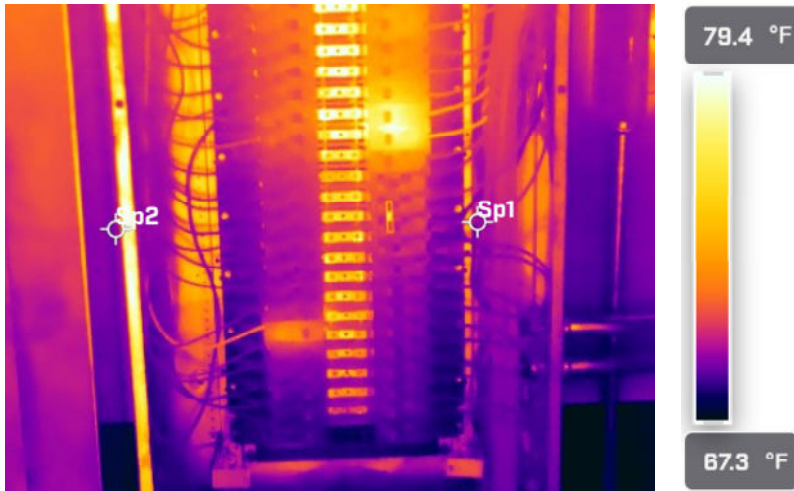
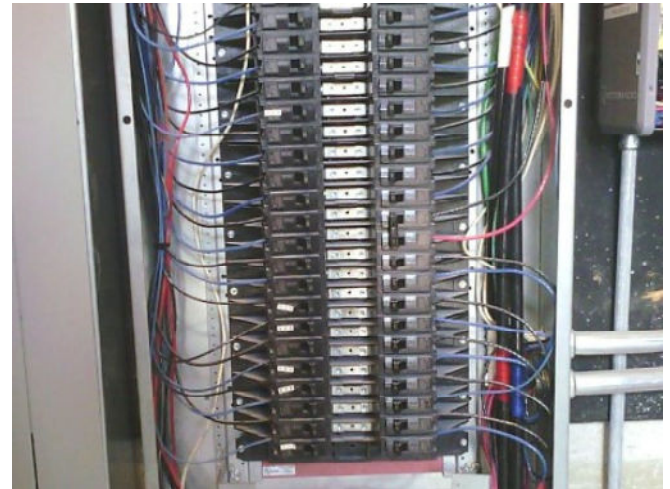
Severity: **Normal**

Floor	1
Location	Electrical Room
Equipment	Breaker Panel Bottom
Item	Panel LA
Details	Y
Anomaly	Normal
Recommendation	No action

**No thermal anomalies or deficiencies found during initial inspection.**

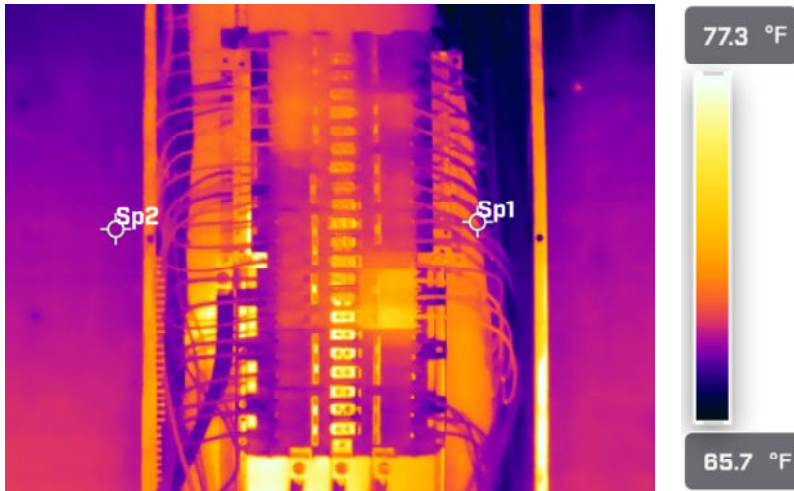
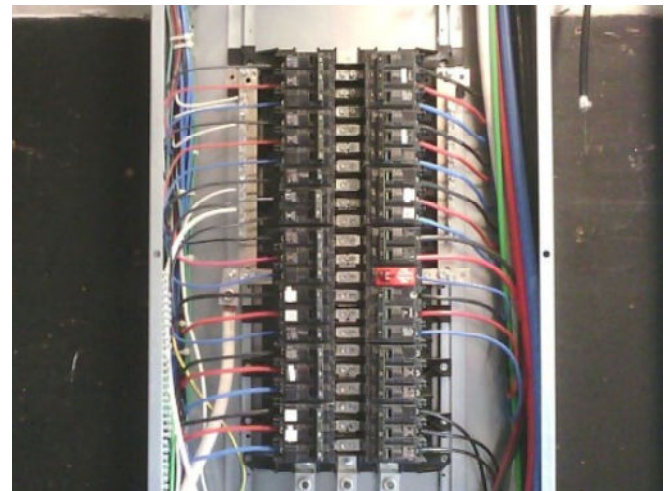
Floor	1
Location	Electrical Room
Equipment	Breaker Panel
Item	Panel LC
Details	Y
Anomaly	Normal
Recommendation	No action

Severity: **Normal**

**No thermal anomalies or deficiencies found during initial inspection.**

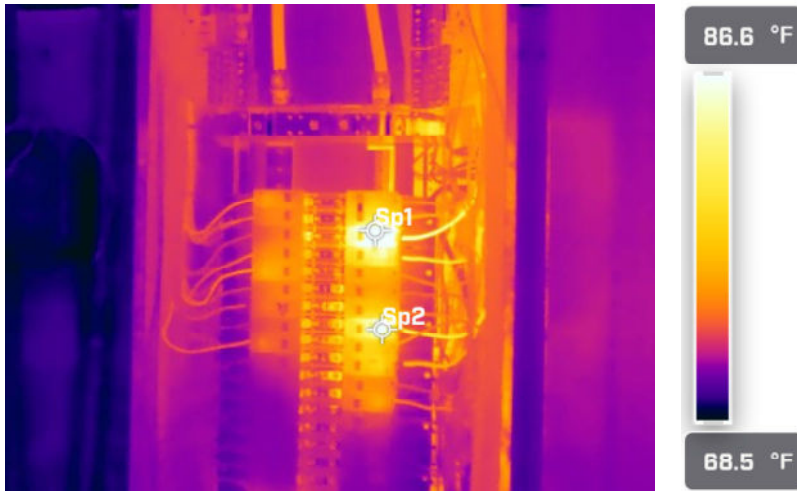
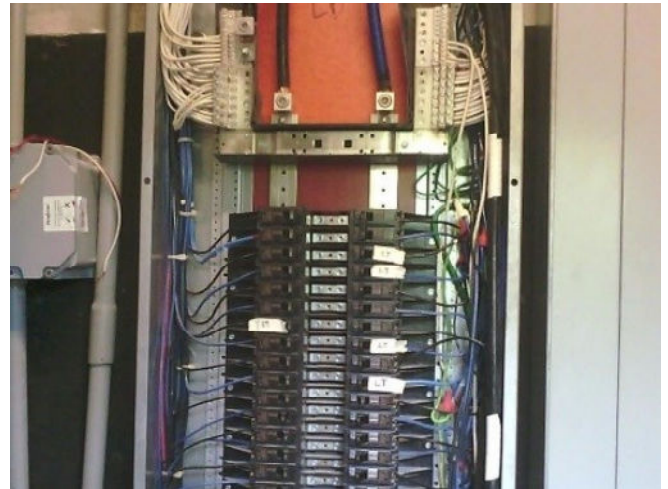
Floor	1
Location	Electrical Room
Equipment	Breaker Panel Top
Item	Panel LB
Details	Y
Anomaly	Normal
Recommendation	No action

Severity: **Normal**

**No thermal anomalies or deficiencies found during initial inspection.**

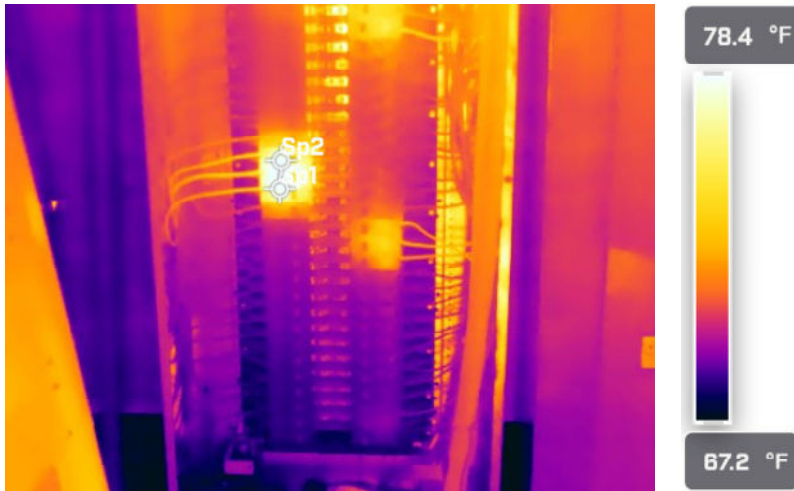
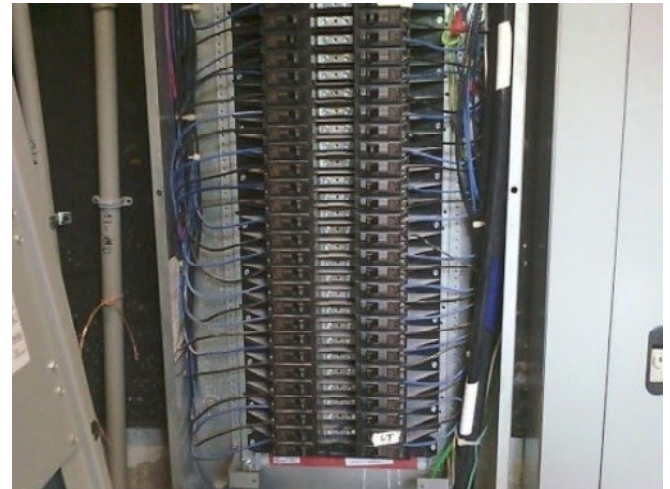
Severity: **Normal**

Floor	1
Location	Electrical Room
Equipment	Breaker Panel Bottom
Item	Panel LB
Details	Y
Anomaly	Normal
Recommendation	No action

**No thermal anomalies or deficiencies found during initial inspection.**

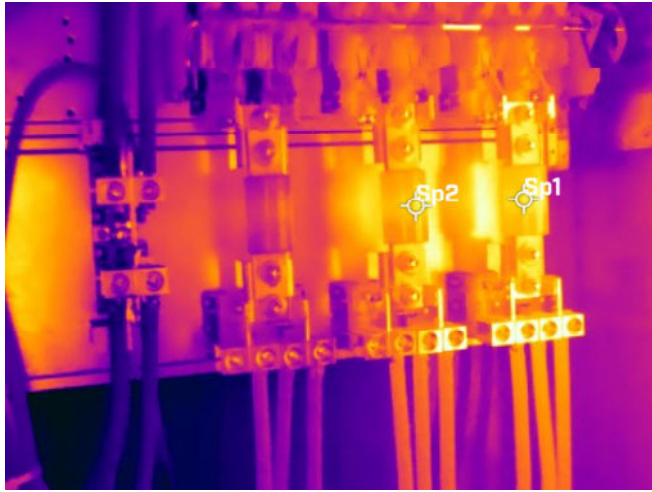
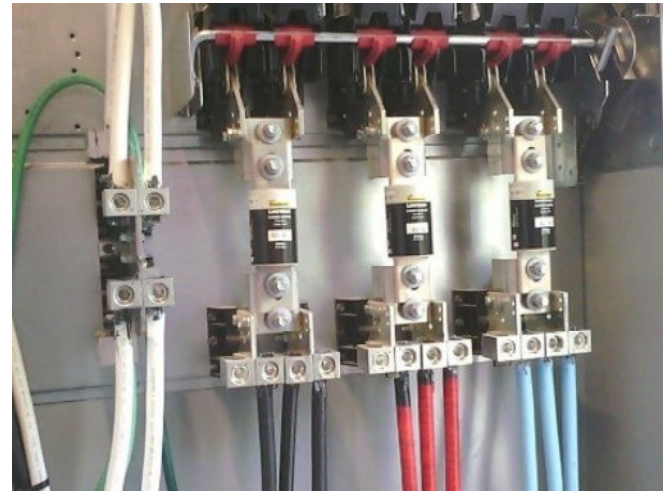
Severity: **Normal**

Floor	1
Location	Electrical Room
Equipment	800AMP Main Fuse Disconnect
Item	Main 1 of 1
Details	Y
Anomaly	Normal
Recommendation	No action

**No thermal anomalies or deficiencies found during initial inspection.**

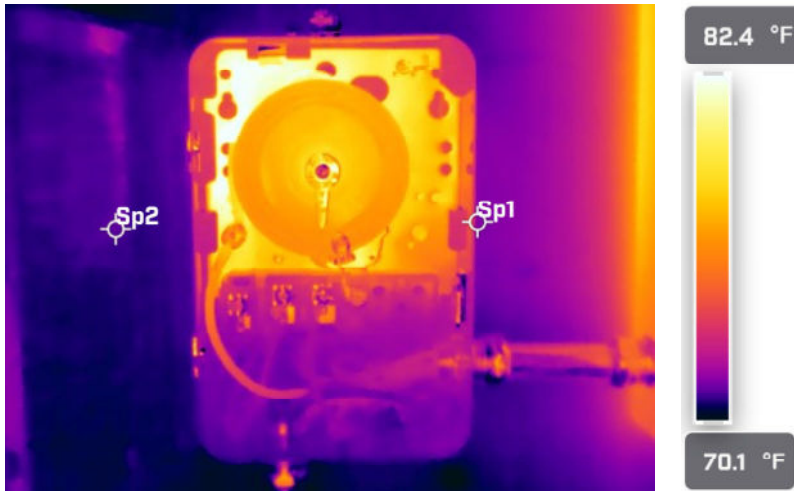
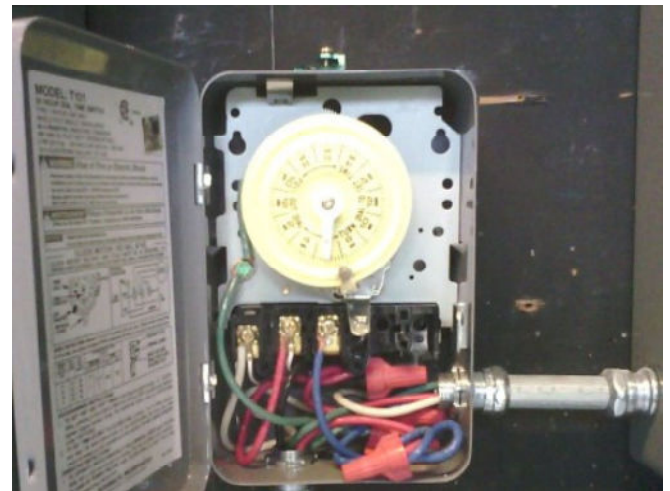
Floor	1
Location	Electrical Room
Equipment	Timer
Item	Exterior Lights
Details	Y
Anomaly	Normal
Recommendation	No action

Severity: **Normal**

**No thermal anomalies or deficiencies found during initial inspection.**

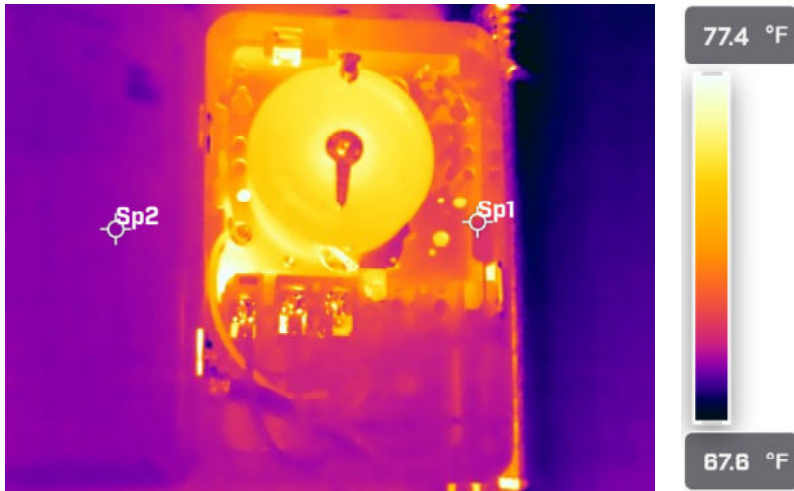
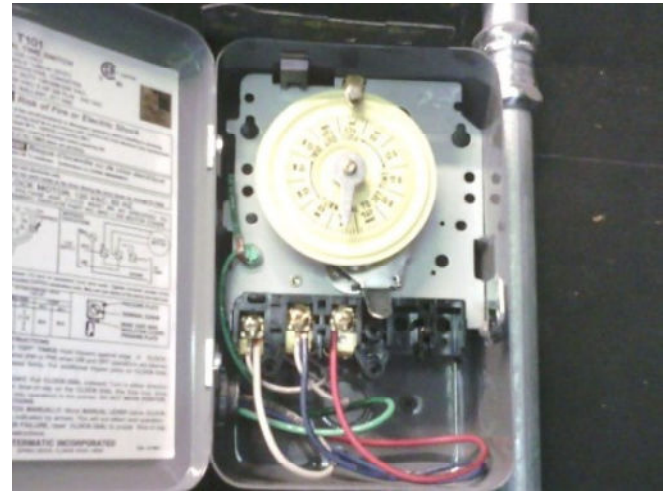
Severity: **Normal**

Floor	1
Location	Electrical Room
Equipment	Timer
Item	2
Details	Y
Anomaly	Normal
Recommendation	No action

**No thermal anomalies or deficiencies found during initial inspection.**

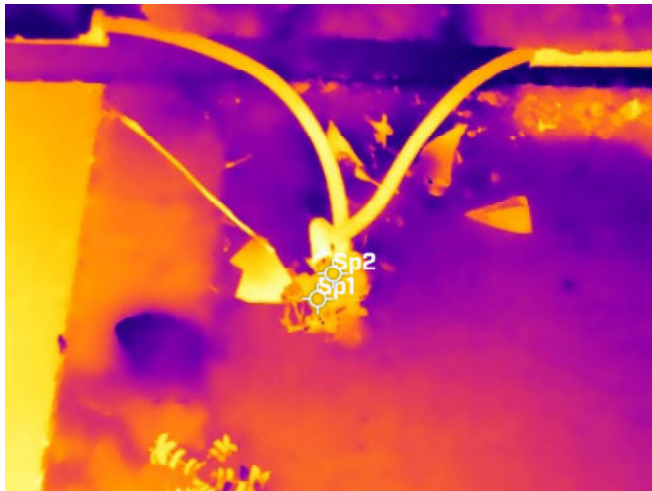
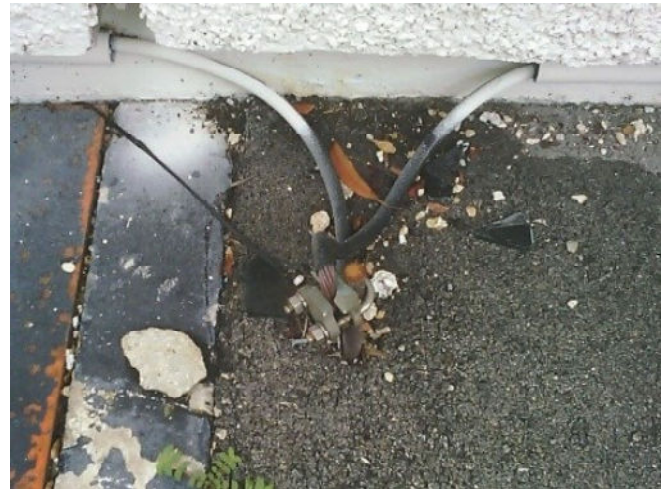
Floor	1
Location	Electrical Room
Equipment	Grounding Rod
Item	1
Details	Y
Anomaly	Normal
Recommendation	No action

Severity: **Normal**

**No thermal anomalies or deficiencies found during initial inspection.**
